# Navajo Abandoned Uranium Mine

# Site Screen Report

## **Plot 8 AUM Site**

August 2010

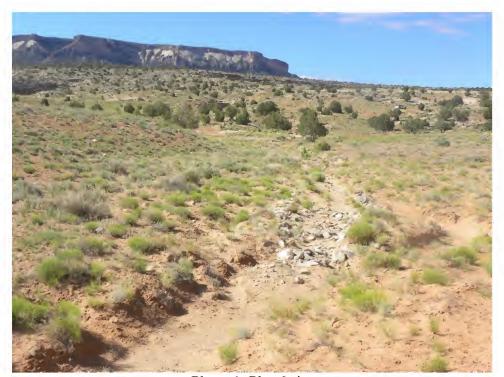
Photo 1. Plot 6 site

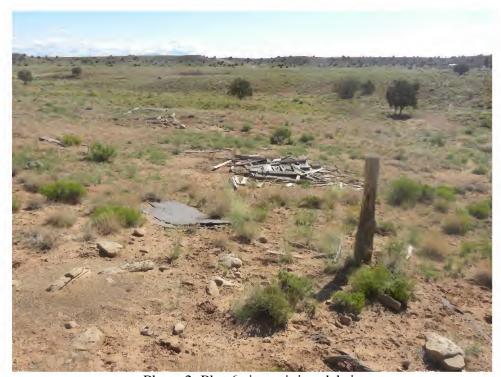
Various wood mining debris throughout site; 2' diameter hole with corrugated metal sleeve, approximately 15' deep; reclamation diversion channel along entire S edge of site

Photo 2. Plot 6 site, mining debris

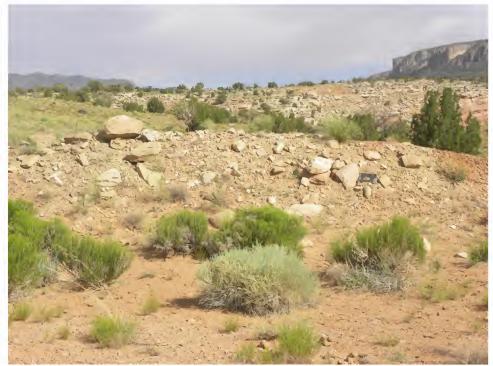
15'x45'x6' waste rock pile with mining debris

Photo 3. Plot 6 site, waste pile

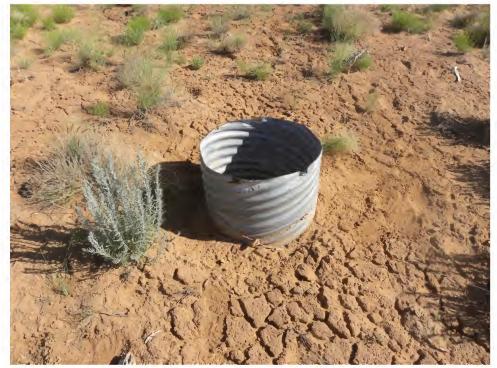
Photo 4. Plot 6 site, lined hole

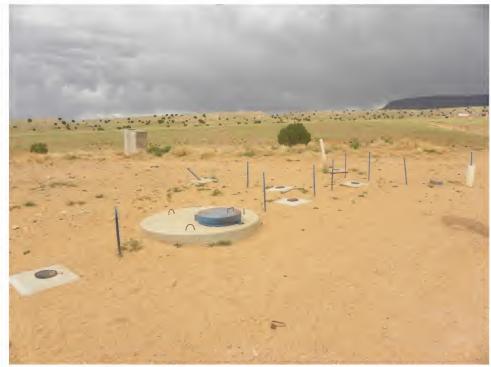
**0 to 0.25 miles:** Well at Clark house, 0.1 mi N of site

Photo 5. Plot 6 site, Clark house well

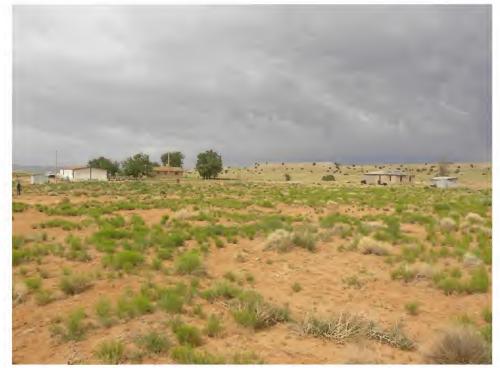
Photo 6. Plot 6 site, Clark house
